RAILWAY INVESTIGATION REPORT
R02E0114

MAIN-TRACK DERAILMENT

CANADIAN PACIFIC RAILWAY

MILE 11.8, TABER SUBDIVISION

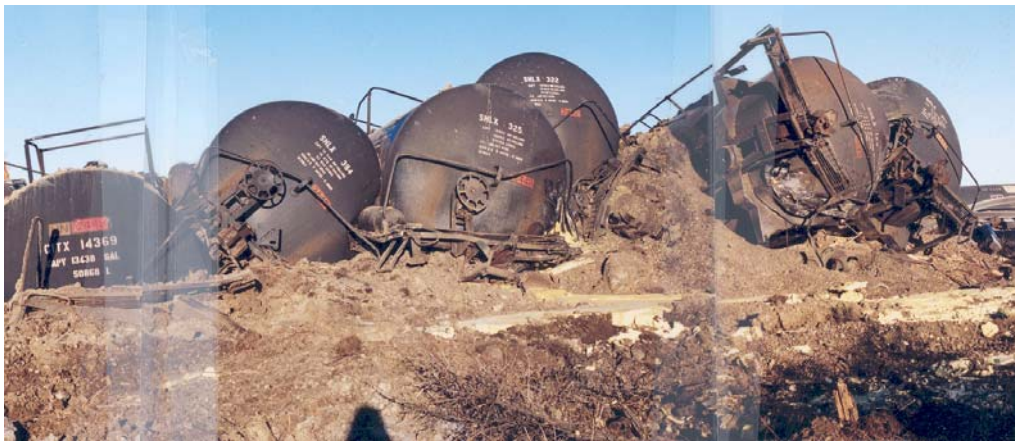
At 0055 mountain standard time¹ on 04 December 2002, Canadian Pacific Railway (CPR) freight train 614-046, proceeding eastward on the CPR Taber Subdivision at approximately 38 mph, derailed at Mile 11.8 after a train-initiated emergency brake application. The crew immediately contacted the rail traffic controller (RTC), who advised the Medicine Hat Fire Department, Seven Persons Fire Department, Ambulance, and the Royal Canadian Mounted Police (RCMP). Inspection of the train revealed that 42 tank cars loaded with liquid sulphur, commencing behind the seventh car, had derailed, 10 of which were on fire. The rear wheels on the eighth car in the consist had derailed. The locomotives and the first eight cars continued approximately 1/4 mile east of the main pile-up. The following 40 cars were jackknifed perpendicular to the track, one beside the other, within 400 feet of the last derailed car, which had derailed leading wheels. About 440 feet of track was destroyed.

Photo 1. Derailed scene with tank cars perpendicular to the track

Forty tank cars were severely damaged and ultimately scrapped. Nine SHLX tank cars and one PROX tank car were breached by dents and punctures to the tank shell heads and sides. Six cars, including the PROX car, were breached with four SHLX cars badly damaged with safety vents sheared off and torn side jackets. None of the tank cars was equipped with head shields; however, a nine per cent increase in puncture resistance was incorporated into the SHLX cars design, as required by Transport Canada's (TC) Equivalent Level of Safety Permit SR 5206. The bottom fitting protection and skid plates on these cars did not prevent the loss of product from some of the cars involved in the derailment. Four cars had the bottom outlet valves sheared off but did not open. All tank cars involved in the derailment were general purpose, insulated, non-pressurized tank cars built without head shields to specification DOT 111A100W2 or 211A100W1 design.

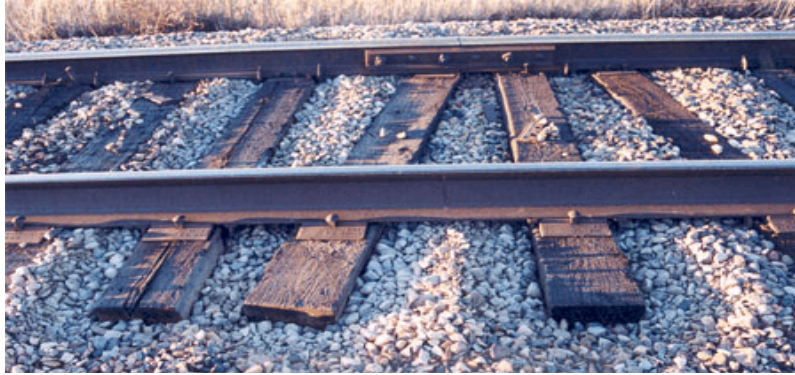
Photo 2. Skewed ties at joint

CPR's SPC 08 covers lining, maintaining, and renewing ties. Section 4.0, Inspecting Ties and Tie Defects, requires ties in the joint area, where support is most needed, to be sound and able to maintain surface and gauge. At each rail joint location, each rail joint must be supported by one non-defective tie with a tie plate no farther than 12 inches from the rail end. The number of defective ties within a joint area on a secondary or feeder line is limited to no more than two and no more than three outside the joint area. While defective tie conditions across the subdivision are not excessive and may not warrant a renewal program across the entire subdivision, overall joint tie conditions in the area of the derailment generally did not meet CPR's SPC 08 standard.

Impact forces imposed by the heavy axle loads and poor ballast and surface conditions led to an increased number of broken joint bars, tie plates, and damaged track ties in joint areas. Skewed ties and rail anchors away from the ties were an indicator of track structure movement instability and rail creep. In addition, the increased use of dynamic braking of heavy unit trains for controlling train speed added additional stress to the track structure. These combined factors reduced the overall track integrity.

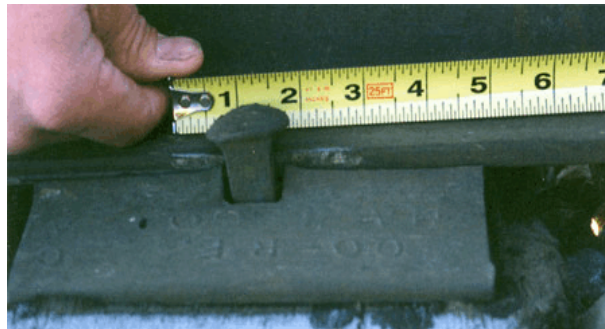
The rail is box-anchored every second tie. At the time of the occurrence, rail anchors were in fair condition, but many were two to three inches away from the ties, indicating rail movement. In some areas of the subdivision, where there is soft track, additional anchors were installed every tie (beyond Standard Practice Circular (SPC) standards) to prevent rail creep.

Photo 3. Indicator of track movement
